**Flood Control Project Maintenance  
Levee Inspections****LMA District Cover Sheet****Spring 2016 Levee Inspection Results****Reclamation District No. 0544 Upper Roberts Island**

**Spring 2016 Levee Inspection Results**

**Reclamation District No. 0544 Upper Roberts Island**

Waterway			Bank	Unit Miles
Unit No. 01 San Joaquin River			Left	6.05
	Spring (March - May)	Summer (June - August)	(September - November) Fall	Winter (December - February)
Unit Maintenance Rating (Fall Only)				
Date of Inspection	4/19/2016 - 4/19/2016			
DWR Inspector	Richard Willoughby			
Accompanied By

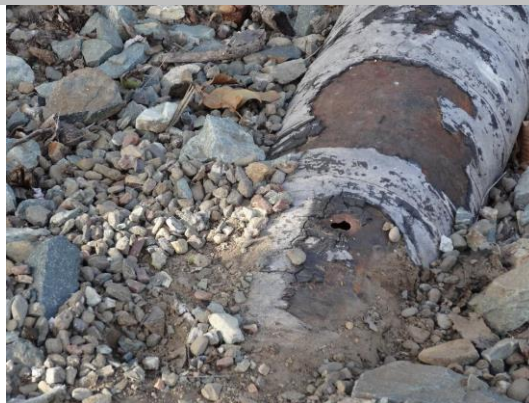
Photo 2 of 2 : UCIP\_SP\_2016\_23851\_41727.jpg

LM Start	0.01	Rating **	M	Issue No.	168
LM End	0.01	Issue Type +	En	Location *	N/A
Category	Supplemental			GPS Latitude/Longitude	
				Start	End
Item	DWR UCIP Field Study			37.870296 °	37.870296 °
				-121.329826 °	-121.329826 °
DWR ID					
Comment Code					
Inspector Comment					
FS_ID:23851 DS_ID:24713 EP_NO: N/A Repair Type: Non-Urgent Crossing Status: Found UCIP Comments: Appears abandoned.May need proper abandonment.Pipe exposed on landside slope. FIELD_STRUCT_DESC: A 12-inch steel pipe through the levee, 2 feet below levee crown. Appears abandoned. Only visible on landside slope. No pipe and other features visible on waterside. FS Date: 10/29/2013

LS view: a 12-inch steel pipe on levee slope. Holes on the pipe, appears abandoned.

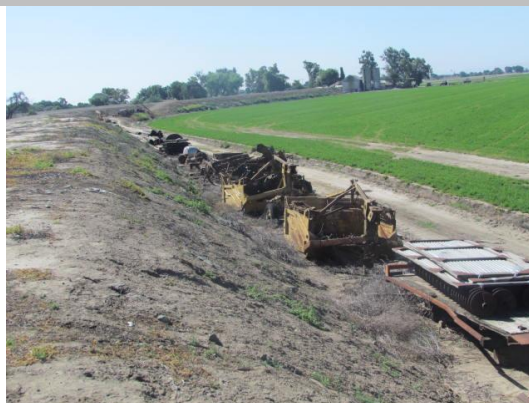
Photo 3 of 5 : SP\_2016\_RD0544\_108\_4\_20160404\_00006.jpg

Looking south at farm equipment at landward toe. (Spring 2015)

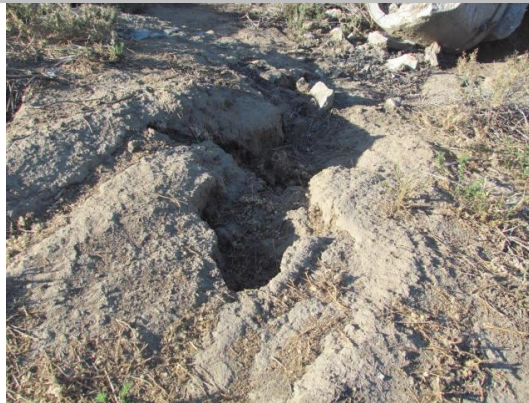
Photo 1 of 1 : SP\_2016\_RD0544\_108\_118\_20160404\_00072.jpg

LM Start	0.06	Rating **	U	Issue No.	118
LM End	0.06	Issue Type +	Ma	Location *	LS
Category	Earthen Levee			GPS Latitude/Longitude	
				Start	End
Item	Erosion / Bank Caving			37.869570 °	37.869570 °
				-121.329556 °	-121.329556 °
DWR ID	DWR_RD0544_01_f_2015_118				
Comment Code					
E1 : Note and monitor erosion site.					
Inspector Comment					
Finger erosion noted on landward slope.

Looking west at landside erosion for shoulder to middle of levee slope.

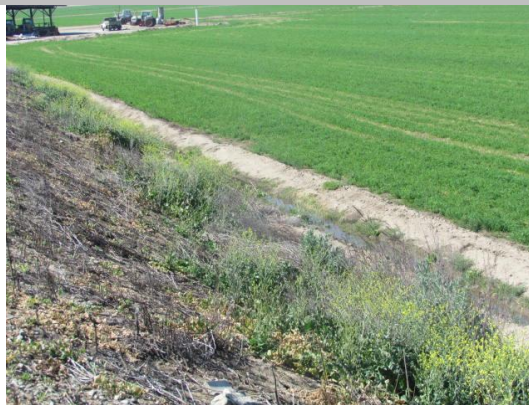
Photo 1 of 1 : SP\_2016\_RD0544\_108\_85\_20160404\_00049.jpg

Looking southwest at Irrigation ditch at landward toe.

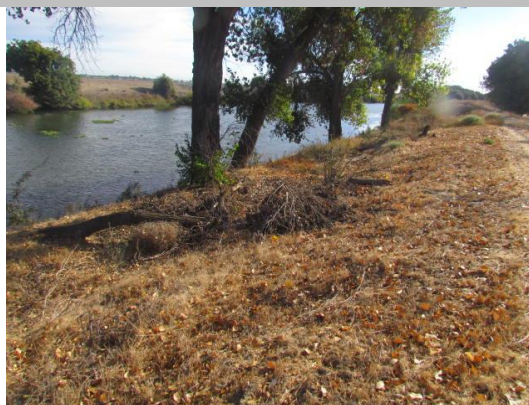
Photo 1 of 1 : SP\_2016\_RD0544\_108\_6\_20160404\_00010.jpg

LM Start	0.45	Rating **	M	Issue No.	6
LM End	0.45	Issue Type +	Ma	Location *	WS
Category	Earthen Levee			GPS Latitude/Longitude	
				Start	End
Item	Encroachments			37.864713 °	37.864713 °
				-121.326708 °	-121.326708 °
DWR ID	DWR_RD0544_01_f_2013_6				
Comment Code					
PR : Prunings					
Inspector Comment					
Broken tree limbs on waterward slope and berm.

Looking southeast at tree branch on waterward slope.

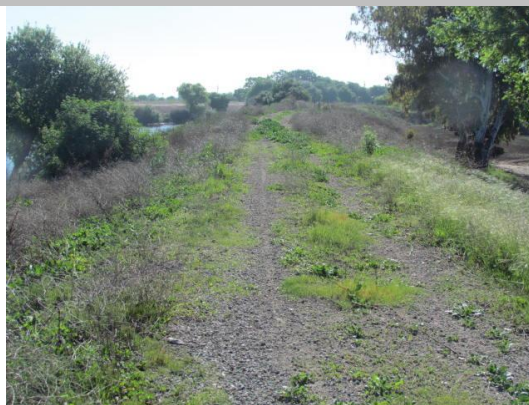
Photo 1 of 2 : SP\_2016\_RD0544\_108\_3\_20160404\_00002.jpg

LM Start	0.48	Rating **	A/W	Issue No.	3
LM End	0.67	Issue Type +	Ma	Location *	WS
Category	Earthen Levee			GPS Latitude/Longitude	
				Start	End
Item	Vegetation			37.864578 °	37.863753 °
				-121.326210 °	-121.322835 °
DWR ID	DWR_RD0544_01_s_2012_3				
Comment Code					
V2 : Remove the wild growth other than native grasses from the levee slopes.					
Inspector Comment					
Issue has been corrected, but should be monitored.

Looking south at typical view of levee. (Spring 2014)

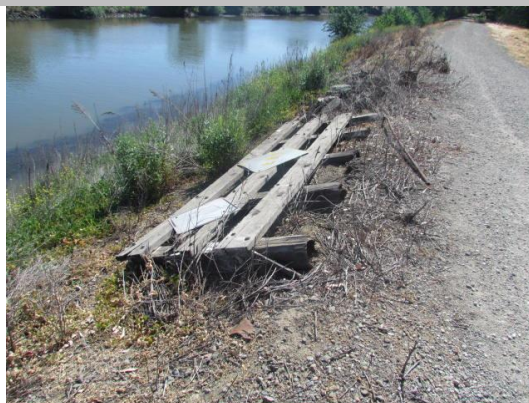
Photo 1 of 1 : SP\_2016\_RD0544\_108\_86\_20160404\_00050.jpg

Looking southeast at wooden sign on waterward slope.

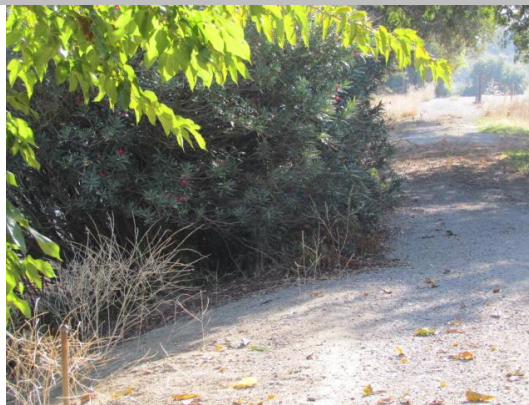
Photo 1 of 1 : SP\_2016\_RD0544\_108\_10\_20160404\_00013.jpg

Looking south at dense oleanders on waterward slope fall 2015.

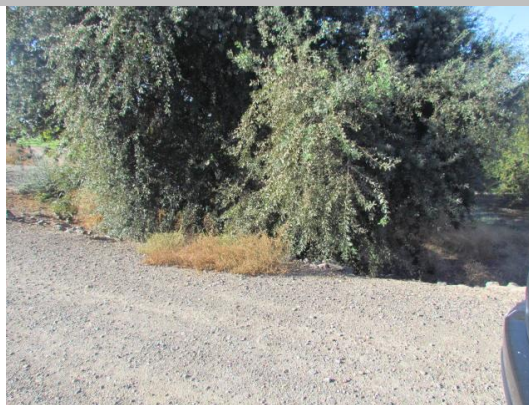
Photo 1 of 1 : SP\_2016\_RD0544\_108\_93\_20160404\_00057.jpg

Looking west at untrimmed trees on landward slope and toe fall 2015.

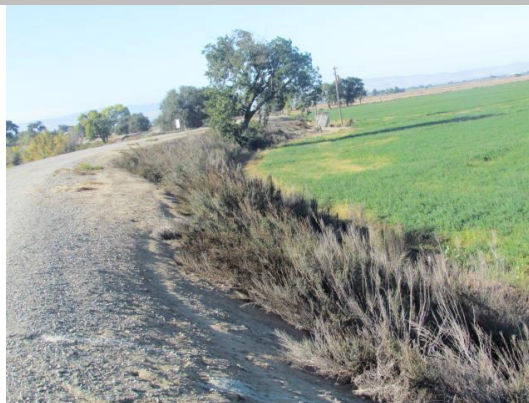
Photo 1 of 1 : SP\_2016\_RD0544\_108\_15\_20160404\_00014.jpg

Looking southeast at dense vegetation on landward toe.

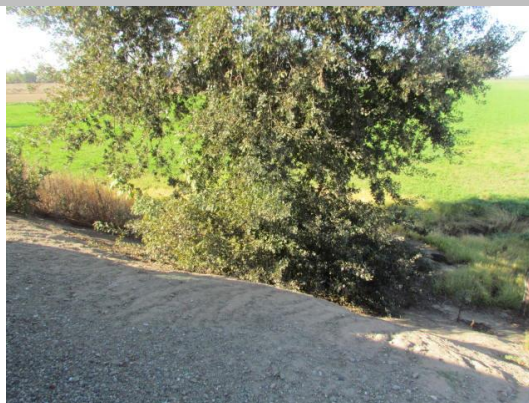
Photo 1 of 1 : SP\_2016\_RD0544\_108\_87\_20160404\_00051.jpg

Looking west at untrimmed tree at landward toe fall 2015.

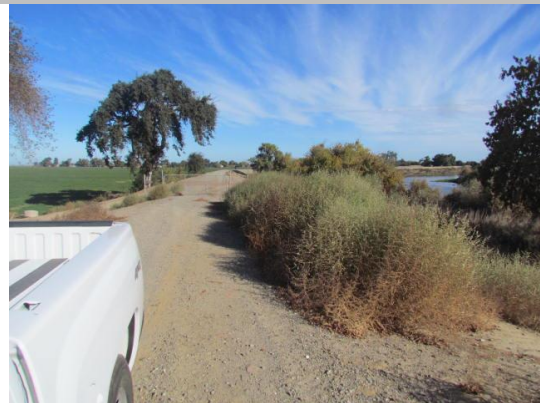
Photo 1 of 1 : SP\_2016\_RD0544\_108\_94\_20160404\_00058.jpg

Looking north at vegetation on waterward shoulder and slope.

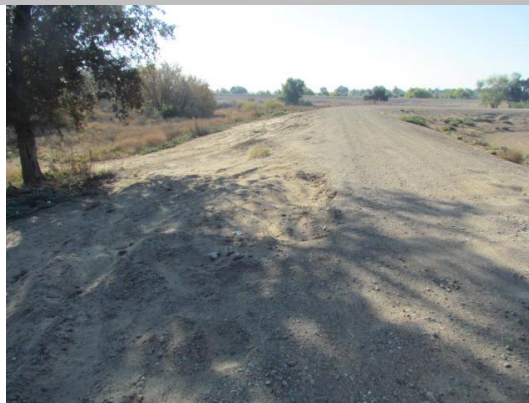
Photo 1 of 3 : SP\_2016\_RD0544\_108\_119\_20160404\_00073.jpg

LM Start	1.50	Rating **	U	Issue No.	119
LM End	1.51	Issue Type +	Ma	Location *	WS
Category	Earthen Levee			GPS Latitude/Longitude	
				Start	End
Item	Slope Stability			37.854844 °	37.854564 °
				-121.321090 °	-121.321031 °
DWR ID	DWR_RD0544_01_f_2015_119				
Comment Code					
S3 : Repair the levee slope damaged by vehicle traffic and prevent access where possible.					
Inspector Comment					
Damaged levee slope due to fishermen using slope as a ramp.

Looking southeast at damaged waterward slope fall 2015.

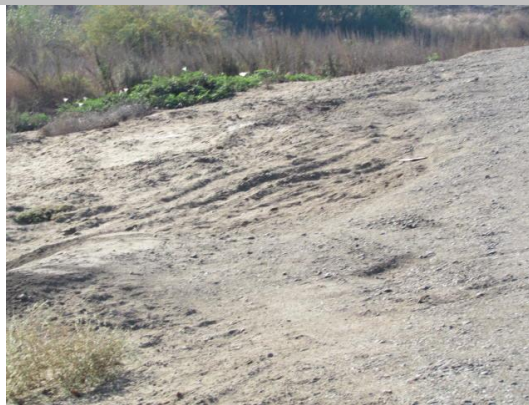
Photo 2 of 3 : SP\_2016\_RD0544\_108\_119\_20160404\_00074.jpg

Looking east at damaged waterward slope fall 2015.

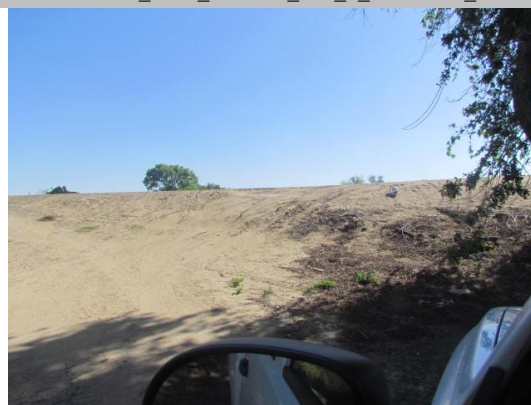
Photo 1 of 1 : SP\_2016\_RD0544\_108\_5\_20160404\_00009.jpg

LM Start	1.82	Rating **	M	Issue No.	5
LM End	1.82	Issue Type +	Ma	Location *	LS
Category	Earthen Levee			GPS Latitude/Longitude	
				Start	End
Item	Slope Stability			37.853188 °	37.853188 °
				-121.324145 °	-121.324145 °
DWR ID	DWR_RD0544_01_s _ 2013_5				
Comment Code					
S3 : Repair the levee slope damaged by vehicle traffic and prevent access where possible.					
Inspector Comment					
Slope damaged by vehicle traffic.

Looking east at landward slope damaged by vehicle traffic.

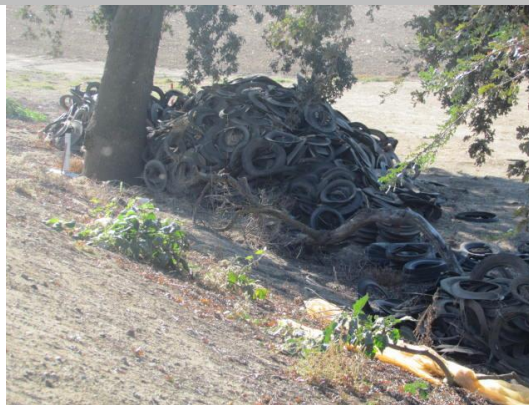
Photo 2 of 2 : SP\_2016\_RD0544\_108\_64\_20160404\_00045.jpg

Looking southwest at rubber tires stored at landward toe.

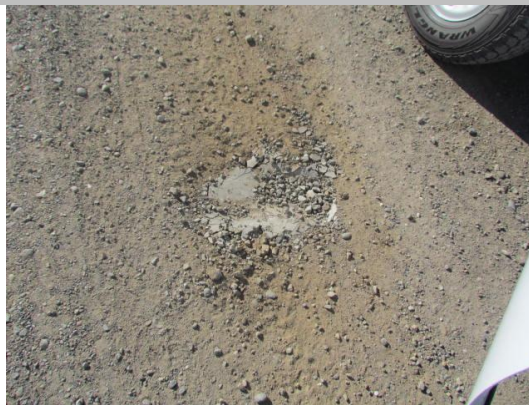
Photo 2 of 2 : SP\_2016\_RD0544\_108\_90\_20160404\_00053.jpg

Looking at grouted rodent hole on levee crown.

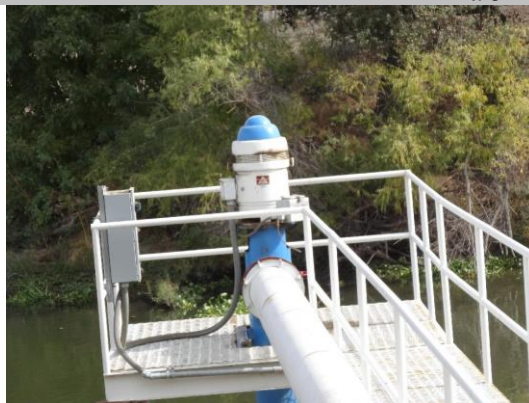
Photo 2 of 2 : UCIP\_SP\_2016\_23945\_42006.jpg

WS view: steel pipe, walkway to the pump, and pump on steel pile structure in the stream.

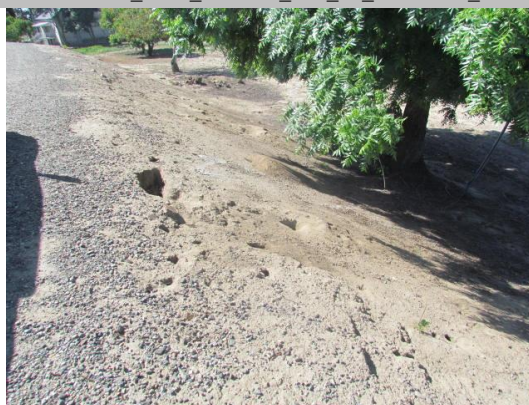
Photo 1 of 2 : SP\_2016\_RD0544\_108\_34\_20160404\_00025.jpg

Looking south at several rodent holes on landward shoulder and slope.

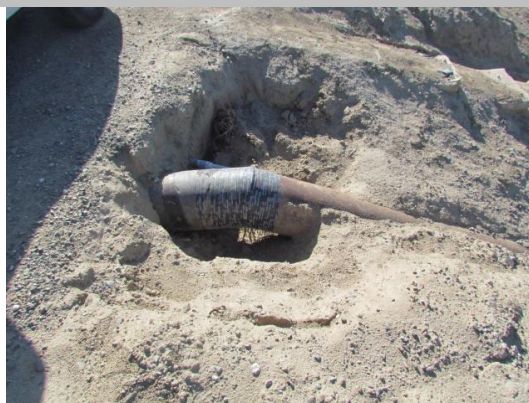
Photo 1 of 3 : SP\_2016\_RD0544\_108\_91\_20160404\_00054.jpg

Looking at open trench around pipe on landward shoulder fall 2015.

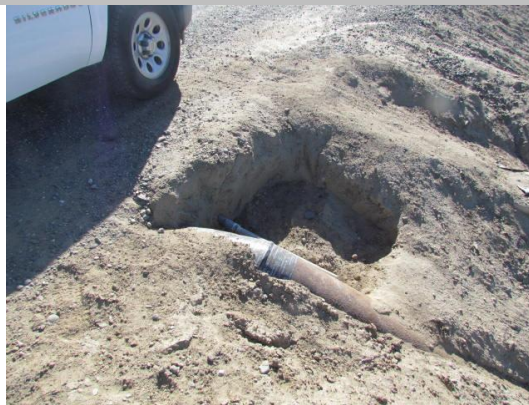
Photo 2 of 3 : SP\_2016\_RD0544\_108\_91\_20160404\_00055.jpg

Looking south at partially open trench around pipe on landward shoulder and slope.

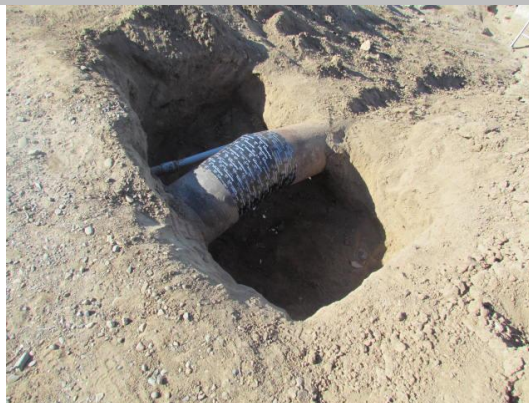
Photo 3 of 3 : SP\_2016\_RD0544\_108\_91\_20160404\_00056.jpg

Looking at open trench with irrigation pipe on landward shoulder and slope.

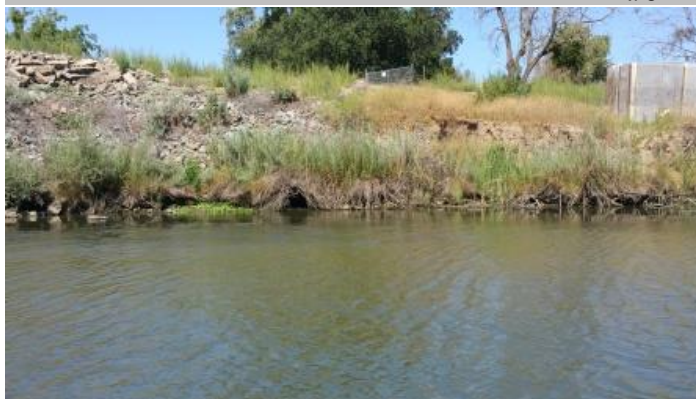
Photo 2 of 2 : SP\_2016\_RD0544\_108\_38\_20160404\_00030.jpg

Front view of the erosion.

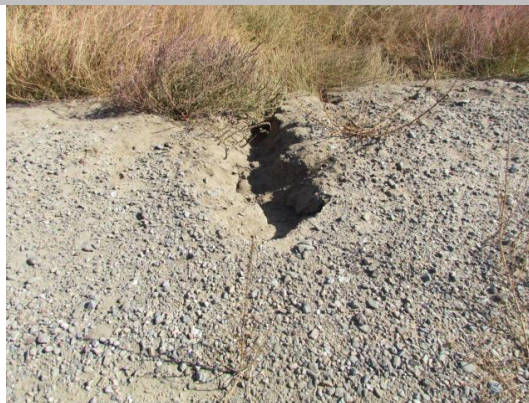
Photo 1 of 1 : SP\_2016\_RD0544\_108\_76\_20160404\_00048.jpg

Looking east at slope damage on waterward slope.

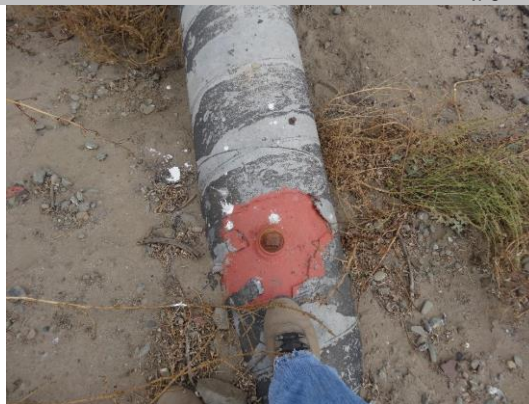
Photo 2 of 2 : UCIP\_SP\_2016\_43026\_44844.jpg

WS view: pipe daylights on levee slope. Siphon breaker removed and plugged.

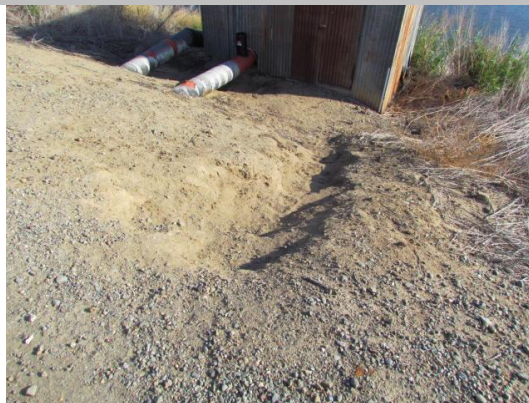
Photo 1 of 1 : SP\_2016\_RD0544\_108\_62\_20160404\_00043.jpg

Looking east at slope damaged by foot traffic near pump house on waterside of levee.

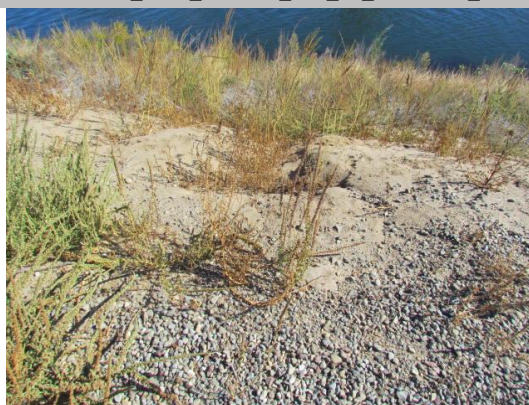
Photo 1 of 1 : SP\_2016\_RD0544\_108\_50\_20160404\_00039.jpg

Looking east at erosion on waterward slope.

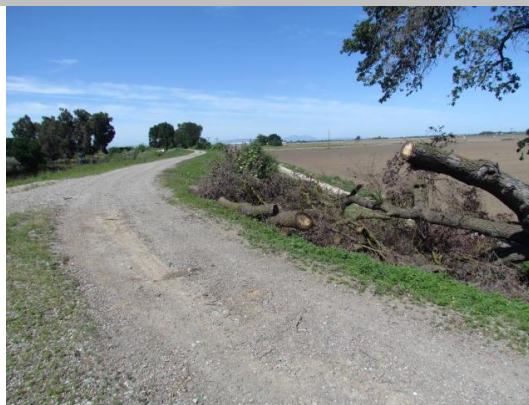
Photo 1 of 2 : SP\_2016\_RD0544\_108\_123\_20160421\_00127.jpg

Looking southwest at tree limbs on landward slope,

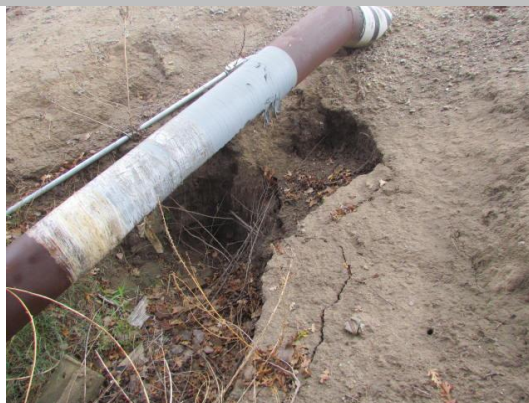
Photo 1 of 2 : SP\_2016\_RD0544\_108\_28\_20160404\_00021.jpg

Looking northeast at erosion around irrigation pipe on landside slope.

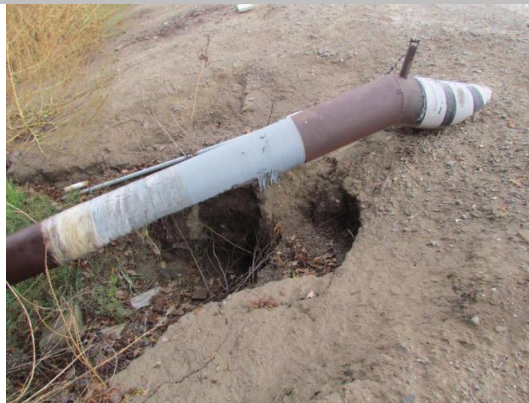
Photo 2 of 2 : SP\_2016\_RD0544\_108\_28\_20160404\_00022.jpg

Looking north at erosion around irrigation pipe on landside

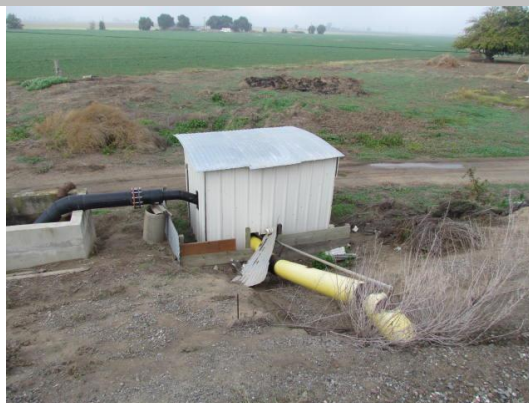
Photo 1 of 1 : SP\_2016\_RD0544\_108\_45\_20160404\_00034.jpg

Looking west at a unauthorized pump house on landside toe.

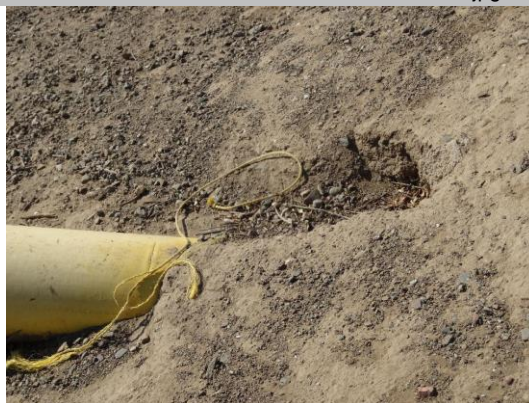
Photo 2 of 2 : UCIP\_SP\_2016\_24894\_44863.jpg

WS view: exposed steel pipe and a small depression on levee slope.  
May be due to leaky pipe.

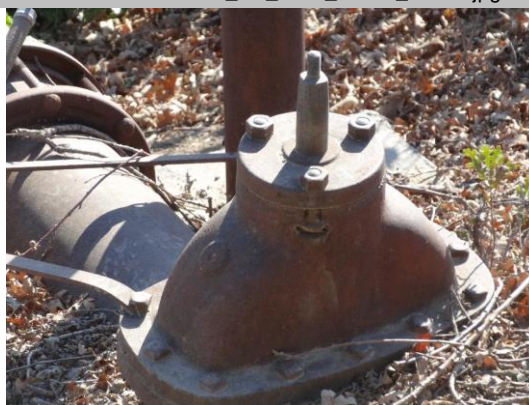
Photo 2 of 2 : UCIP\_SP\_2016\_42962\_42876.jpg

WS view: gate valve without handwheel on levee slope.

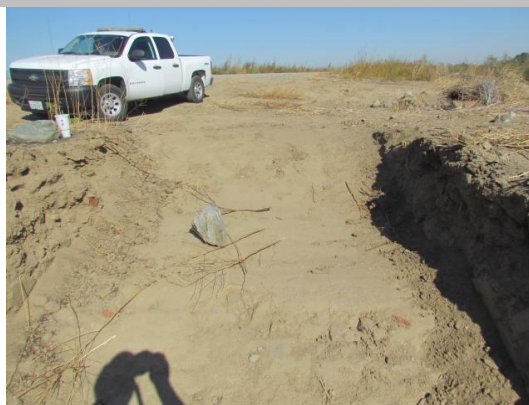
Photo 1 of 4 : SP\_2016\_RD0544\_108\_121\_20160404\_00076.jpg

Looking west at excavation on waterward berm.

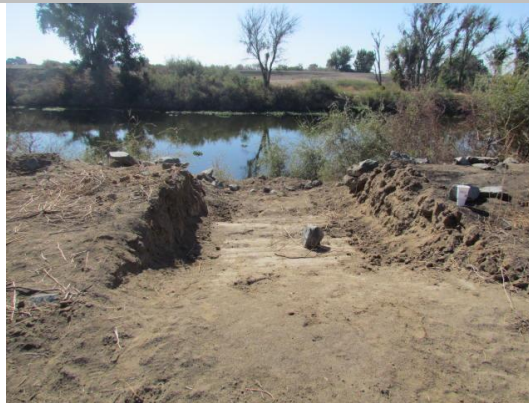
Photo 2 of 4 : SP\_2016\_RD0544\_108\_121\_20160404\_00077.jpg

Looking east at excavation on waterward berm.

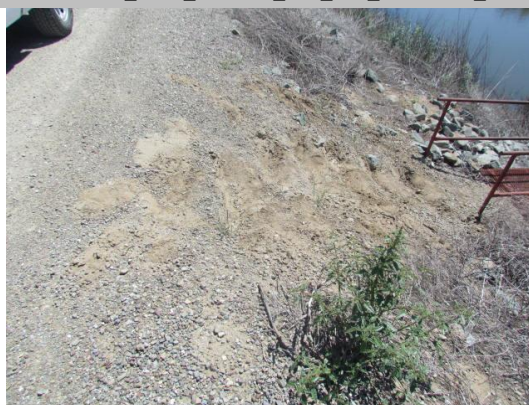
Photo 2 of 3 : SP\_2016\_RD0544\_108\_115\_20160404\_00070.jpg

Looking east at slope damage on waterward slope.

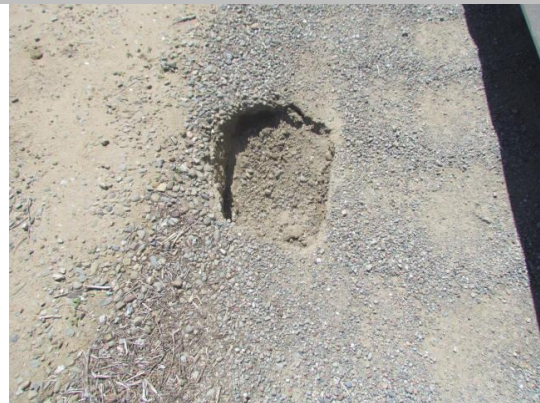
Photo 1 of 1 : SP\_2016\_RD0544\_109\_46\_20160404\_00040.jpg

Looking at depression on landward shoulder.

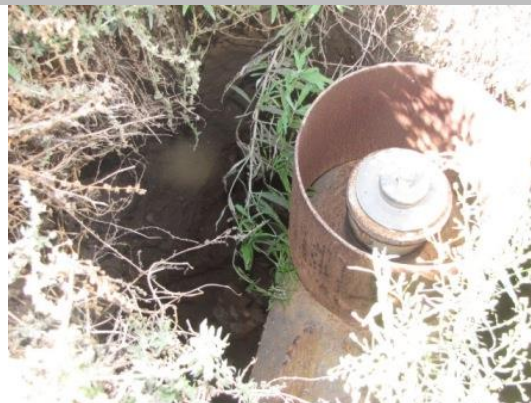
Photo 2 of 8 : SP\_2016\_RD0544\_109\_8\_20160404\_00008.jpg

Looking at caving around 10" siphon pipe on waterside shoulder.

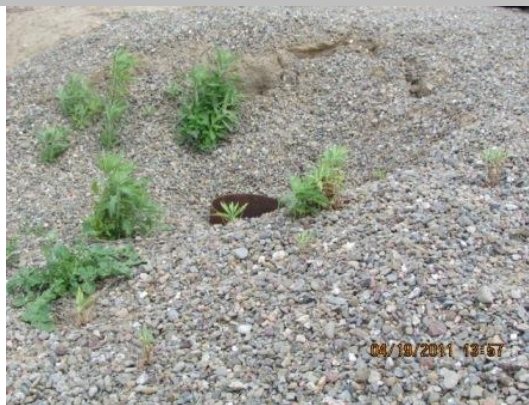
Photo 8 of 8 : SP\_2016\_RD0544\_109\_8\_20160404\_00014.jpg

Looking south at depression greater than 6" around siphon on waterside shoulder.

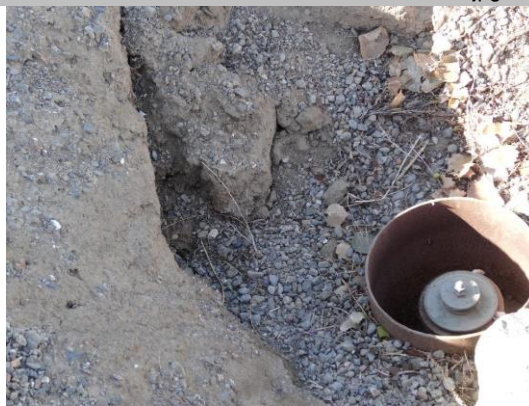
Photo 2 of 2 : UCIP\_SP\_2016\_24903\_44881.jpg

WS view: depression on levee slope around siphon breaker. Siphon breaker in steel pipe riser.

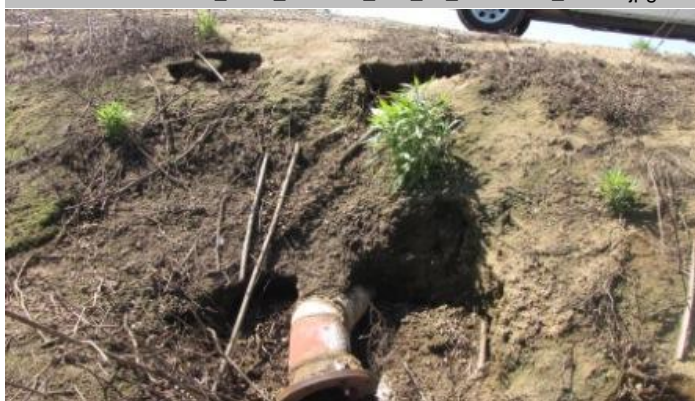
Photo 3 of 3 : SP\_2016\_RD0544\_109\_21\_20160404\_00030.jpg

Looking east at pipe and erosion just above pipe on landside slope and shoulder.

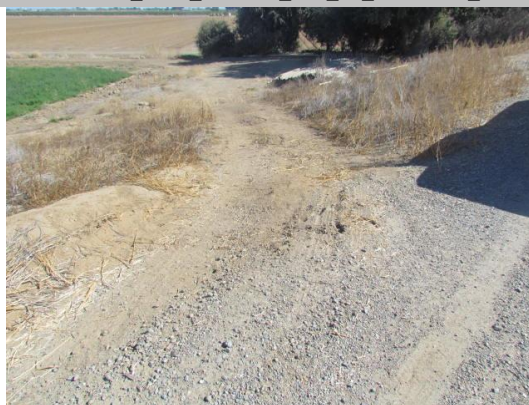
Photo 1 of 2 : SP\_2016\_RD0544\_109\_22\_20160404\_00031.jpg

Looking northwest at slope damage caused by vehicle traffic (Fall 2014).

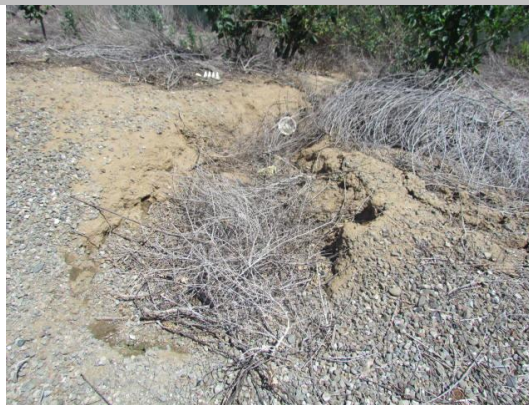
Photo 2 of 2 : SP\_2016\_RD0544\_109\_38\_20160404\_00038.jpg

Looking east at erosion/caving on waterward slope.

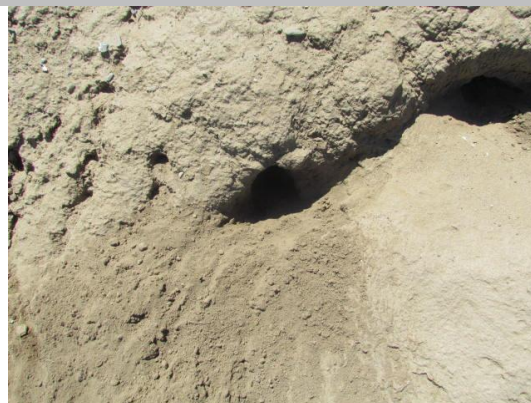
Photo 1 of 1 : SP\_2016\_RD0544\_109\_58\_20160404\_00049.jpg

Looking at typical rodent holes on landward slope.

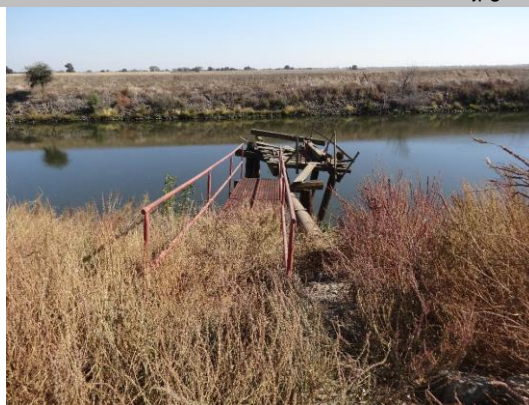
Photo 1 of 2 : UCIP\_SP\_2016\_24295\_42972.jpg

WS view: dilapalated walkway and pile structure. Pump removed.

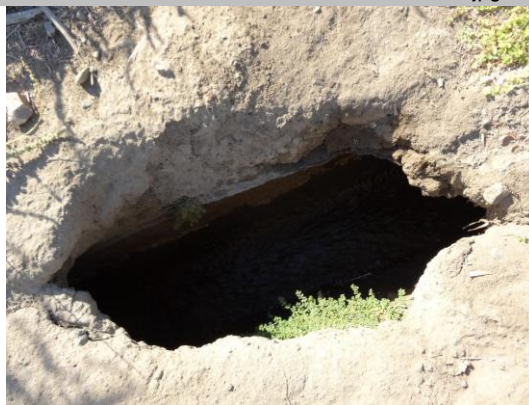
Photo 2 of 2 : UCIP\_SP\_2016\_46064\_43004.jpg

WS view: close view of levee slope with pits and holes.
